Flood Control Project Maintenance
2020 Structure Summary Report
Overall Unit and Item Ratings

Lower San Joaquin Levee District

Ash Slough Drop Structure No. 1

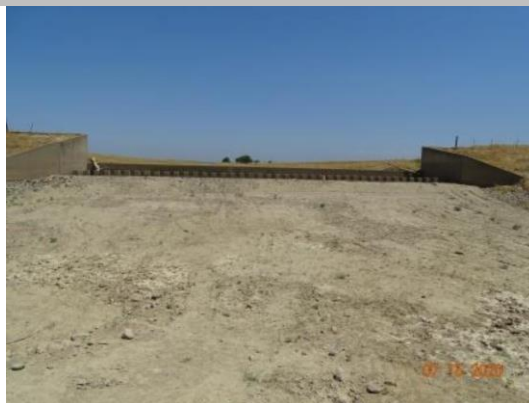
Photo 1 of 3 : ST_2020_NA0010_24_1_20200721_00013.jpg

Overview of the downstream side of the structure. (2020)

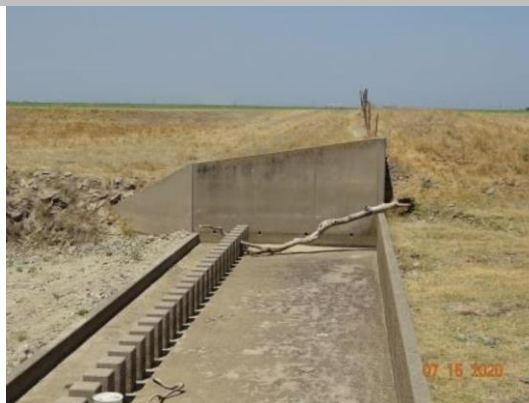
Photo 2 of 3 : ST_2020_NA0010_24_1_20200721_00012.jpg

View of the right wing wall. (2020)

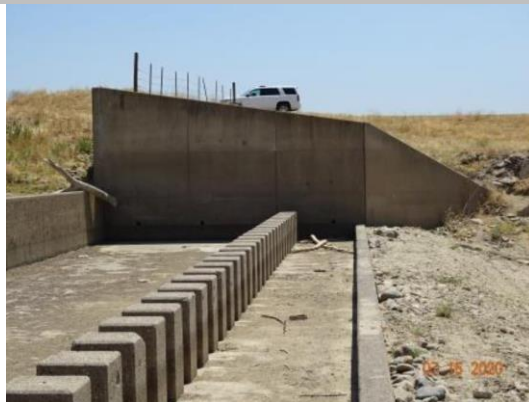
Photo 3 of 3 : ST_2020_NA0010_24_1_20200721_00014.jpg

View of the left wing wall. (2020)

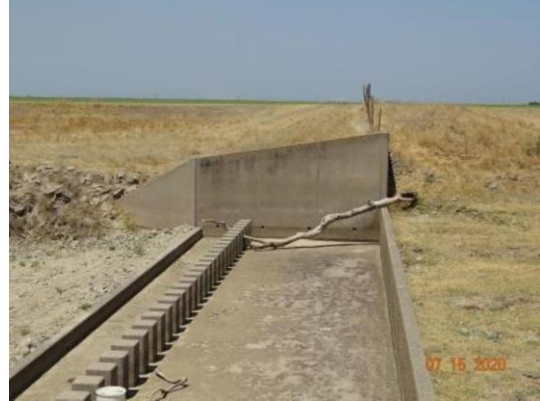
Photo 1 of 1 : ST_2020_NA0010_24_2_20200721_00020.jpg

LM Start	0.00	Rating **	M	Issue No.	2
LM End	0.00	Issue Type +	Ma	Location *	
Category	Structures & Concrete Lined Channels	GPS Latitude/Longitude			
		Start		End	
Item	Vegetation & Obstructions	37.033952 °		37.033952 °	
		-120.441733 °		-120.441733 °	
DWR ID	DWR_NA0010_24_t_2012_2				
Action/Comments					
Inspector Comments: No vegetation or obstructions that would impede flow. Tree limb caught on dissipator near the right wing wall.

Tree limb near the right wing wall. (2020)

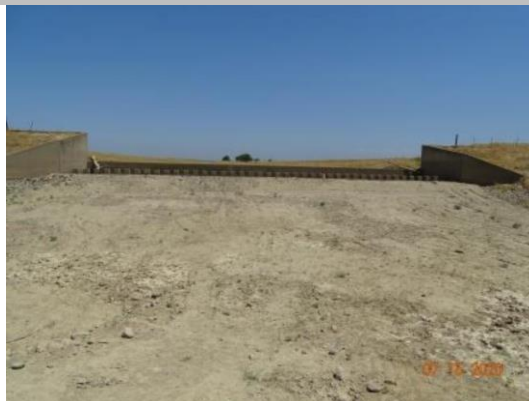
Photo 1 of 2 : ST_2020_NA0010_24_5_20200721_00017.jpg

LM Start	0.00	Rating **	A	Issue No.	5
LM End	0.00	Issue Type +	Ma	Location *	
Category	Structures & Concrete Lined Channels	GPS Latitude/Longitude			
		Start		End	
Item	Revetments	37.033952 °		37.033952 °	
		-120.441733 °		-120.441733 °	
DWR ID	DWR_NA0010_24_t_2012_5				
Action/Comments					
Inspector Comments: Structure revetment appears to be well maintained.

View of downstream revetment placed after 2019's inspection. (2020)

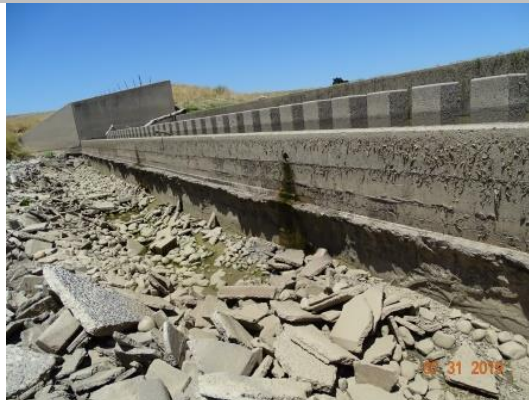
Photo 2 of 2 : ST_2020_NA0010_24_5_20200610_00008.jpg

Downstream revetment has been washed away. (2019)

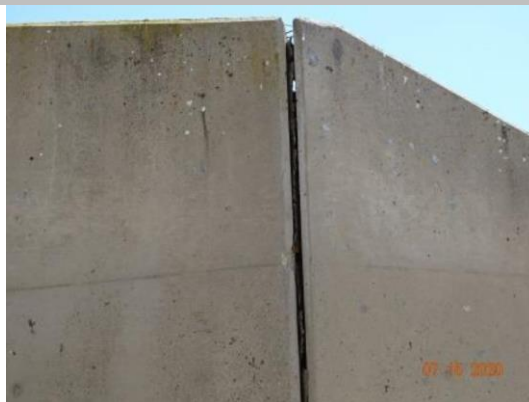
Photo 2 of 2 : ST_2020_NA0010_24_22_20200721_00019.jpg

LM Start	0.00	Rating **	A	Issue No.	22
LM End	0.00	Issue Type +	Ma	Location *	
Category	Structures & Concrete Lined Channels			GPS Latitude/Longitude	
				Start	End
Item	Monolith Joints			37.033952 °	37.033952 °
				-120.441733 °	-120.441733 °
DWR ID	DWR_NA0010_24_t_2012_22				
Action/Comments					
Inspector Comments: Joint gaskets on the wing walls appear to be deteriorating. Monitor for potential repairs.

View of monolith joint at the left wing wall. (2020)

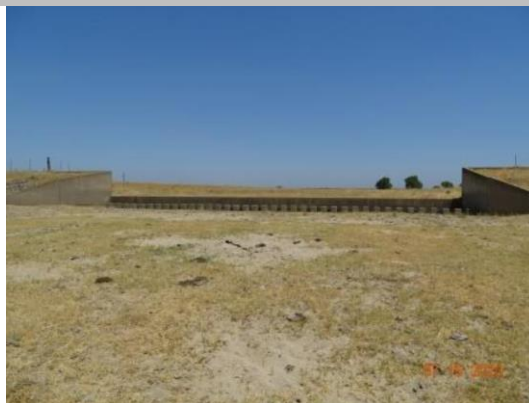
Photo 1 of 3 : ST_2020_NA0010_25_1_20200721_00014.jpg

Overview of downstream side of the structure. (2020)

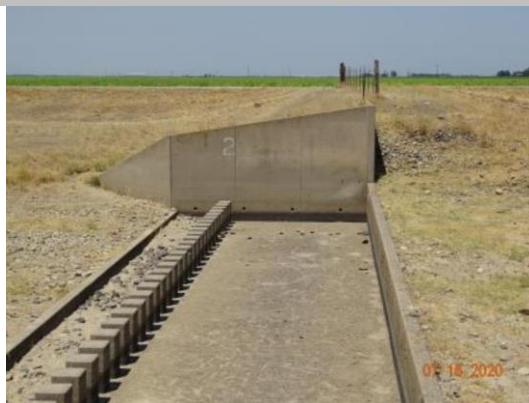
Photo 2 of 3 : ST_2020_NA0010_25_1_20200721_00013.jpg

View of the right wing wall. (2020)

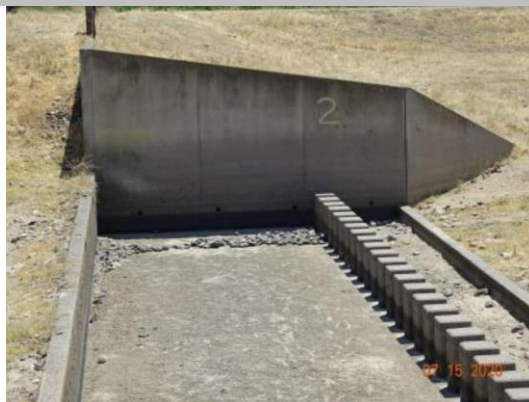
Photo 3 of 3 : ST_2020_NA0010_25_1_20200721_00015.jpg

View of left wing wall. (2020)

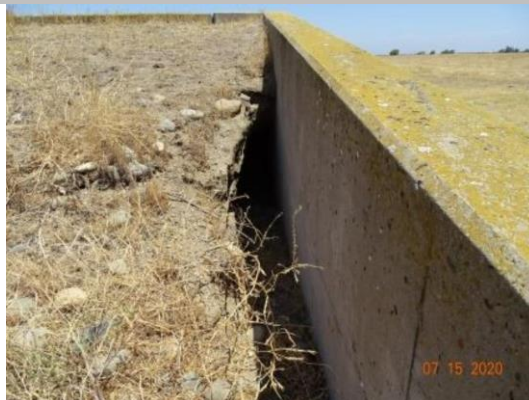
Photo 1 of 4 : ST_2020_NA0010_25_4_20200721_00016.jpg

LM Start	0.00	Rating **	M	Issue No.	4
LM End	0.00	Issue Type +	Ma	Location *	
Category	Structures & Concrete Lined Channels	GPS Latitude/Longitude			
		Start		End	
Item	Erosion / Bank Caving	37.037853 °		37.037853 °	
		-120.440067 °		-120.440067 °	
DWR ID	DWR_NA0010_25_t_2012_4				
Action/Comments					
Inspector Comments: Large hole on the exterior of the right side wall 2-3 feet wide and 4-5 feet deep and 6-8 feet long. This erosion extends back to the headwall which is visible.

Erosion at right wing wall. (2020)

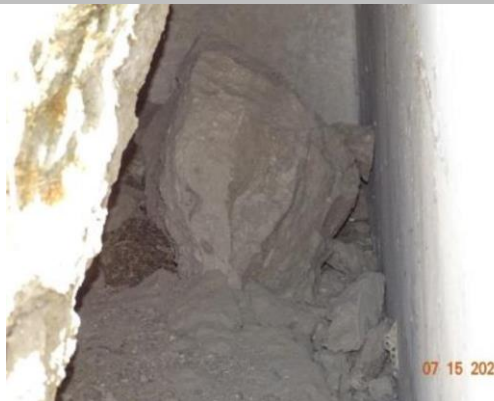
Photo 2 of 4 : ST_2020_NA0010_25_4_20200721_00020.jpg

View inside erosion pocket. (2020)

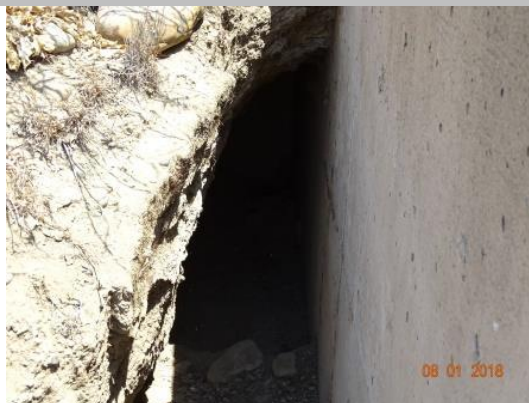
Photo 3 of 4 : ST_2020_NA0010_25_4_20200610_00005.jpg

Erosion at right sidewall (2018)

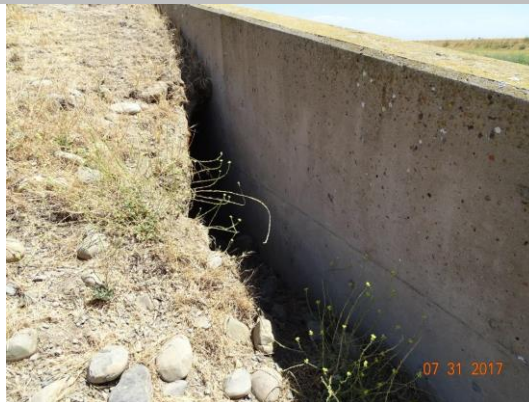
Photo 4 of 4 : ST_2020_NA0010_25_4_20200610_00006.jpg

Erosion on the right sidewall (2017)

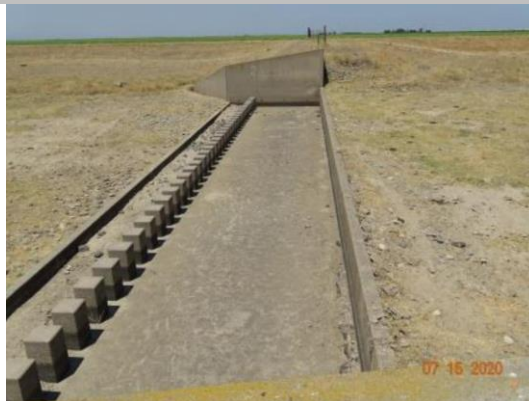
Photo 1 of 1 : ST_2020_NA0010_25_5_20200721_00021.jpg

LM Start	0.00	Rating **	A	Issue No.	5
LM End	0.00	Issue Type +	Ma	Location *	
Category	Structures & Concrete Lined Channels			GPS Latitude/Longitude	
				Start	End
Item	Revetments			37.037853 °	37.037853 °
				-120.440067 °	-120.440067 °
DWR ID	DWR_NA0010_25_t_2012_5				
Action/Comments					
Inspector Comments: Existing revetment appears to be adequate, but is partially obscured by sand.

View of revetment looking towards the right bank. (2020)

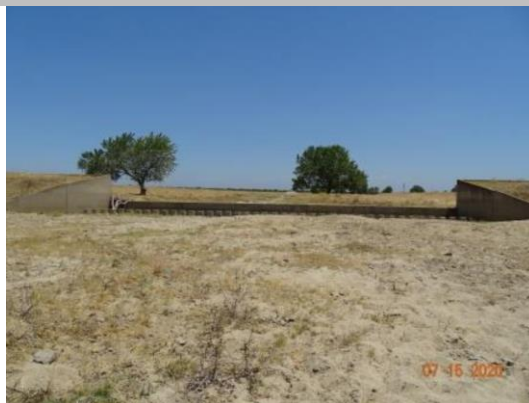
Photo 1 of 3 : ST_2020_NA0010_26_1_20200721_00012.jpg

Overview of the downstream side of the structure. (2020)

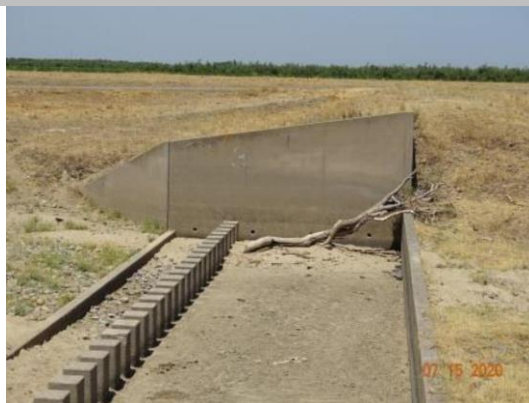
Photo 2 of 3 : ST_2020_NA0010_26_1_20200721_00011.jpg

View of the right wing wall. (2020)

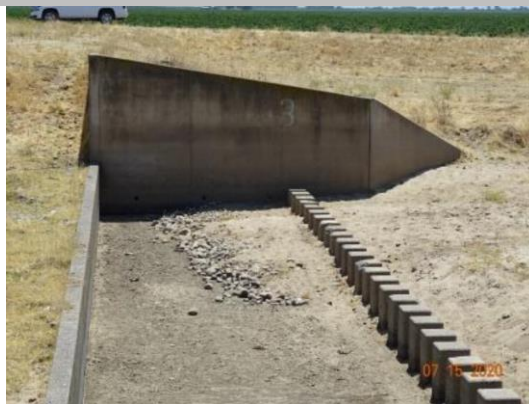
Photo 3 of 3 : ST_2020_NA0010_26_1_20200721_00013.jpg

View of the left wing wall. (2020)

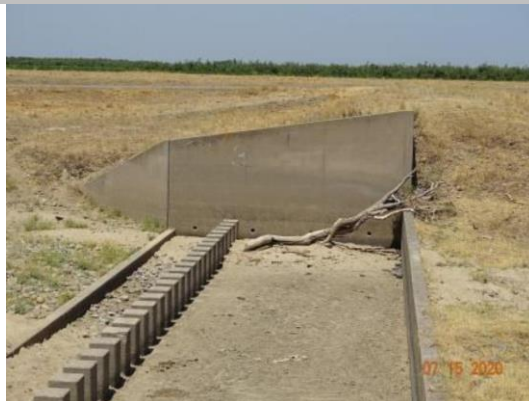
Photo 1 of 1 : ST_2020_NA0010_26_2_20200721_00014.jpg

LM Start	0.00	Rating **	M	Issue No.	2
LM End	0.00	Issue Type +	Ma	Location *	
Category	Structures & Concrete Lined Channels	GPS Latitude/Longitude			
		Start		End	
Item	Vegetation & Obstructions	37.042767 °		37.042767 °	
		-120.436323 °		-120.436323 °	
DWR ID	DWR_NA0010_26_t_2012_2				
Action/Comments					
Inspector Comments: Tree branch caught along right wing wall of structure.

Tree limb caught along the right wing wall. (2020)

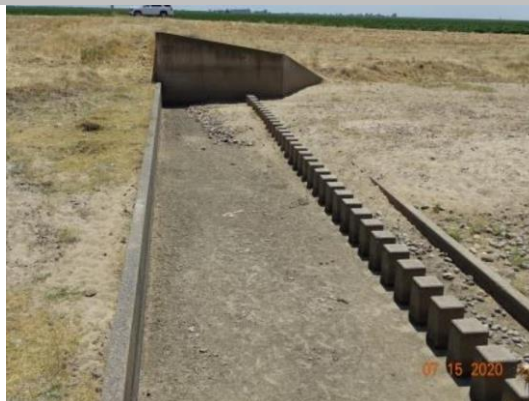
Photo 1 of 2 : ST_2020_NA0010_26_3_20200721_00015.jpg

LM Start	0.00	Rating **	M	Issue No.	3
LM End	0.00	Issue Type +	Ma	Location *	
Category	Structures & Concrete Lined Channels	GPS Latitude/Longitude			
		Start		End	
Item	Shoaling / Sedimentation	37.042767 °		37.042767 °	
		-120.436323 °		-120.436323 °	
DWR ID	DWR_NA0010_26_t_2012_3				
Action/Comments					
Inspector Comments: Sedimentation on the upstream side of structure and also on the downstream side of the left wingwall area.

Sediment accumulating near the left wing wall. (2020)

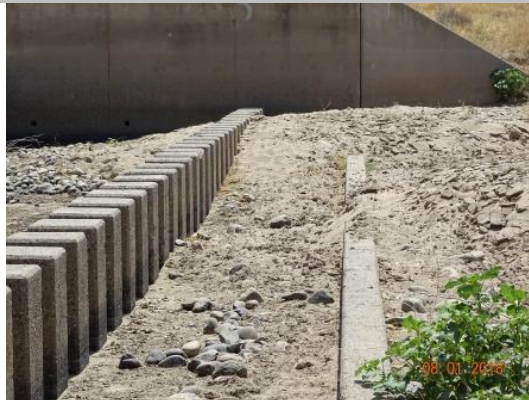
Photo 2 of 2 : ST_2020_NA0010_26_3_20200610_00006.jpg

Sedimentation near left wing wall (2018)

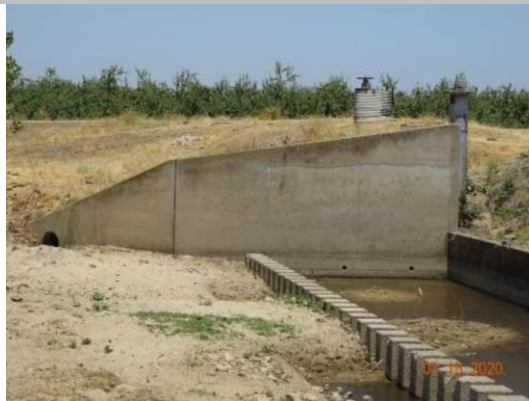
Photo 1 of 3 : ST_2020_NA0010_27_1_20200721_00023.jpg

View of the right wing wall. (2020)

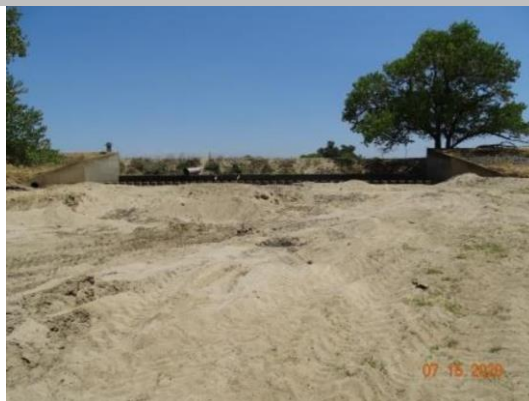
Photo 2 of 3 : ST_2020_NA0010_27_1_20200721_00024.jpg

Overview of the downstream side of the structure. (2020)

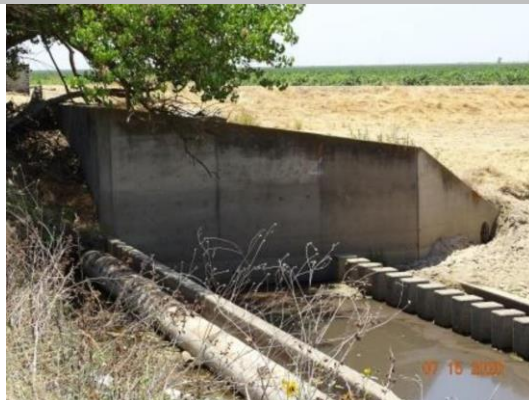
Photo 3 of 3 : ST_2020_NA0010_27_1_20200721_00025.jpg

View of the left wing wall. (2020)

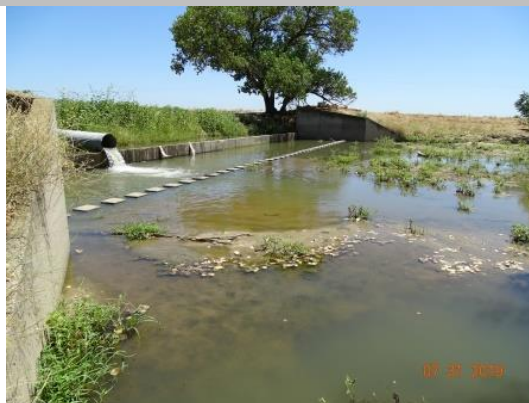
Photo 1 of 2 : ST_2020_NA0010_27_2_20200610_00004.jpg

View of tree growing at the left head wall. (2019)

LM Start	0.00	Rating **	M	Issue No.	2
LM End	0.00	Issue Type +	Ma	Location *	
Category	Structures & Concrete Lined Channels	GPS Latitude/Longitude			
		Start		End	
Item	Vegetation & Obstructions	37.045045 °		37.045045 °	
		-120.429855 °		-120.429855 °	
DWR ID	DWR_NA0010_27_t_2012_2				
Action/Comments					
Inspector Comments: Trees should be removed from around structure.

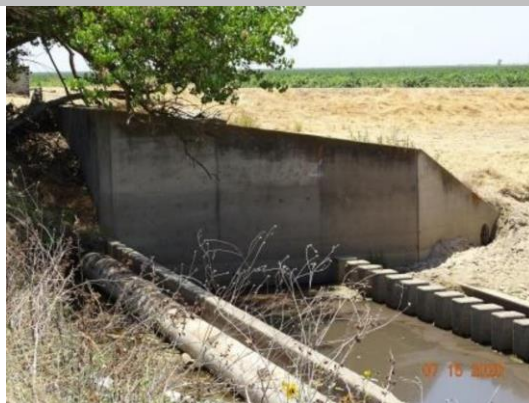
Photo 1 of 1 : ST_2020_NA0010_27_3_20200721_00026.jpg

LM Start	0.00	Rating **	A	Issue No.	3
LM End	0.00	Issue Type +	Ma	Location *	
Category	Structures & Concrete Lined Channels	GPS Latitude/Longitude			
		Start		End	
Item	Shoaling / Sedimentation	37.045045 °		37.045045 °	
		-120.429855 °		-120.429855 °	
DWR ID	DWR_NA0010_27_t_2012_3				
Action/Comments					
Inspector Comments: Minor sedimentation on the downstream left bank side of the structure at the metal culvert outlet.

Sedimentation downstream along the left wall. (2020)

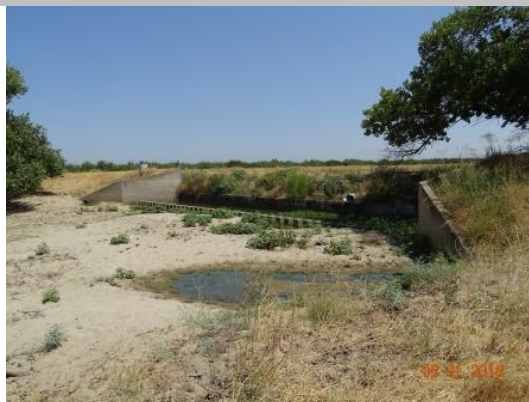
Photo 1 of 1 : ST_2020_NA0010_27_5_20200610_00009.jpg

LM Start	0.00	Rating **	A	Issue No.	5
LM End	0.00	Issue Type +	Ma	Location *	
Category	Structures & Concrete Lined Channels			GPS Latitude/Longitude	
				Start	End
Item	Revetments			37.045045 °	37.045045 °
				-120.429855 °	-120.429855 °
DWR ID	DWR_NA0010_27_t_2012_5				
Action/Comments					
Inspector Comments: No revetment visible on upstream side of structure. Downstream revetment is covered by sand. Recommend maintenance to ensure revetment is adequate.

View of downstream side of structure looking upstream. (2018)

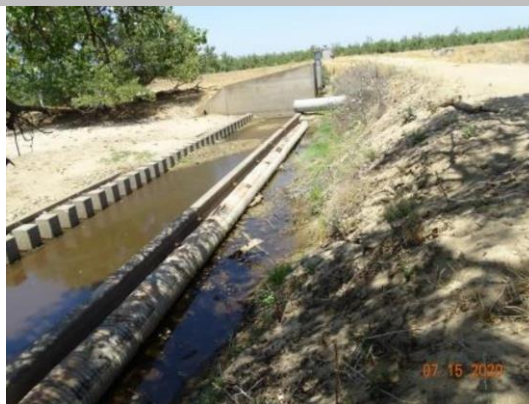
Photo 1 of 3 : ST_2020_NA0010_27_6_20200721_00028.jpg

LM Start	0.00	Rating **	U	Issue No.	6
LM End	0.00	Issue Type +	En	Location *	
Category	Structures & Concrete Lined Channels	GPS Latitude/Longitude			
		Start		End	
Item	Encroachments	37.045045 °		37.045045 °	
		-120.429855 °		-120.429855 °	
DWR ID	DWR_NA0010_27_t_2012_6				
Action/Comments					
Inspector Comments: Landowner is blocking the structure with a sand dam. Additionally, the landowner installed unauthorized pipes through the unauthorized sand dam.

View along unauthorized sand dam from the left bank. (2020)

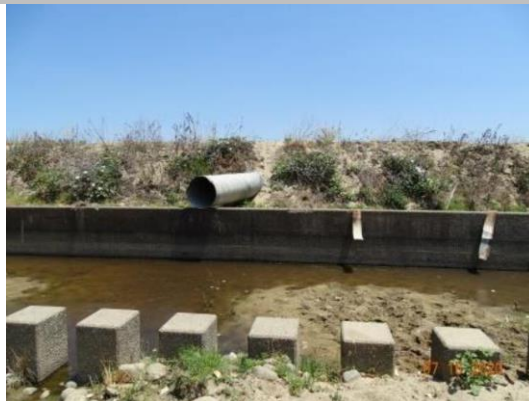
Photo 2 of 3 : ST_2020_NA0010_27_6_20200721_00027.jpg

View of the other unauthorized pipes through the unauthorized earthen dam. (2020)

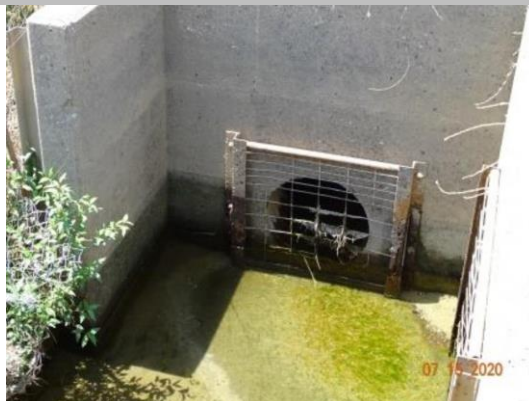
Photo 1 of 4 : ST_2020_NA0010_27_7_20200721_00030.jpg

LM Start	0.00	Rating **	A	Issue No.	7
LM End	0.00	Issue Type +	Ma	Location *	
Category	Structures & Concrete Lined Channels	GPS Latitude/Longitude			
		Start	End		
Item	Culverts: Inlets / Outlets	37.045045 °	37.045045 °		
		-120.429855 °	-120.429855 °		
DWR ID	DWR_NA0010_27_t_2012_7				
Action/Comments					
Inspector Comments: The structure has 1 CMP culvert at the base of each wingwall that appear to be in good shape with no visible signs of deterioration.

View of inlet on the right bank. (2020)

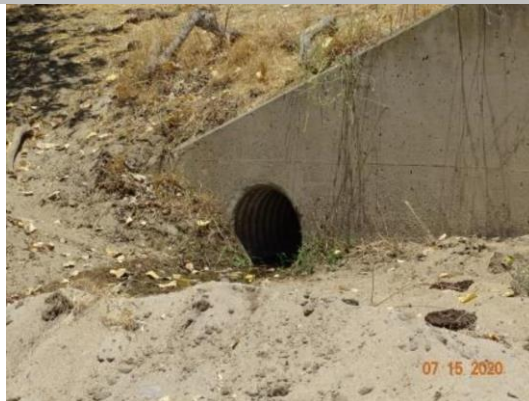
Photo 2 of 4 : ST_2020_NA0010_27_7_20200721_00029.jpg

View of outlet at the right wing wall. (2020)

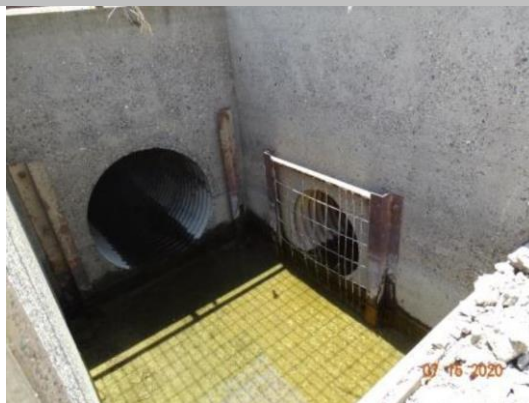
Photo 3 of 4 : ST_2020_NA0010_27_7_20200721_00031.jpg

View of inlet at the left bank. (2020)

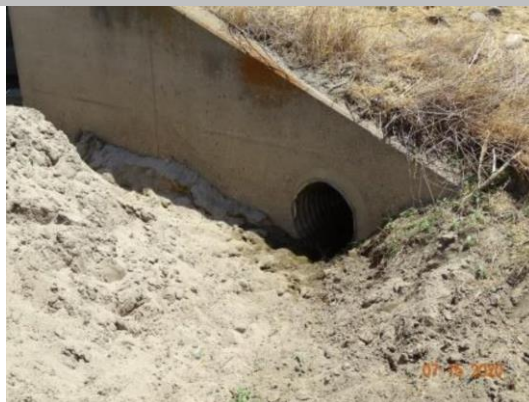
Photo 4 of 4 : ST_2020_NA0010_27_7_20200721_00032.jpg

LM Start	0.00	Rating **	A	Issue No.	7 (cont)	
LM End	0.00	Issue Type +	Ma	Location *		
Category	Structures & Concrete Lined Channels			GPS Latitude/Longitude		
				Start	End	
Item	Culverts: Inlets / Outlets			37.045045 °	37.045045 °	
				-120.429855 °	-120.429855 °	
DWR ID	DWR_NA0010_27_t_2012_7					
Action/Comments						
Inspector Comments: The structure has 1 CMP culvert at the base of each wingwall that appear to be in good shape with no visible signs of deterioration.

View of outlet at the left wing wall. (2020)

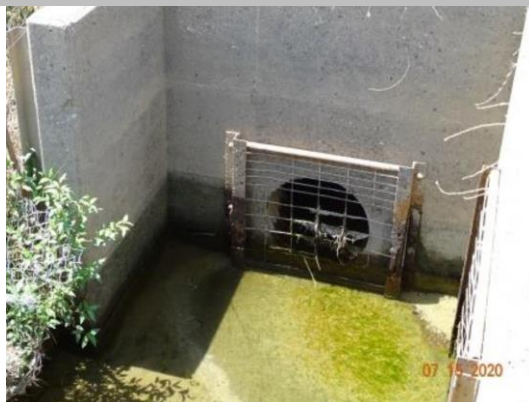
Photo 1 of 3 : ST_2020_NA0010_27_9_20200721_00033.jpg

LM Start	0.00	Rating **	A	Issue No.	9
LM End	0.00	Issue Type +	Ma	Location *	
Category	Structures & Concrete Lined Channels	GPS Latitude/Longitude			
		Start	End		
Item	Metal Pipes	37.045045 °		37.045045 °	
		-120.429855 °		-120.429855 °	
DWR ID	DWR_NA0010_27_t_2012_9				
Action/Comments					
Inspector Comments: The structure has 1 metal culvert at the base of each wing wall that appear to be in good shape with no visible signs of deterioration. 1 CMP along the headwall that connects between the culverts on each wing wall.

Inlet for right wing wall CMP. (2020)

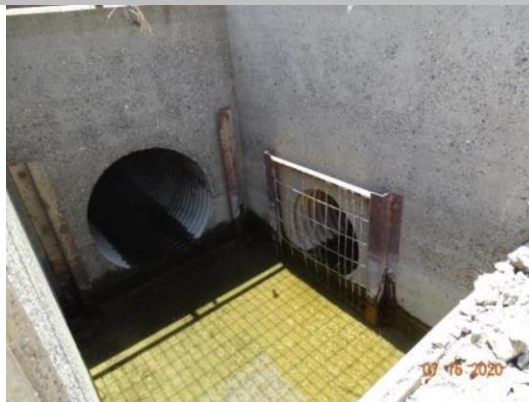
Photo 2 of 3 : ST_2020_NA0010_27_9_20200721_00034.jpg

Inlet for left wing wall CMP. (2020)

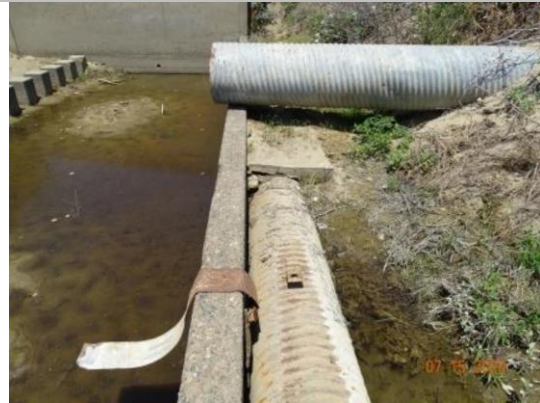
Photo 3 of 3 : ST_2020_NA0010_27_9_20200721_00035.jpg

LM Start	0.00	Rating **	A	Issue No.	9 (cont)	
LM End	0.00	Issue Type +	Ma	Location *		
Category	Structures & Concrete Lined Channels			GPS Latitude/Longitude		
				Start		End
Item	Metal Pipes			37.045045 °		37.045045 °
				-120.429855 °		-120.429855 °
DWR ID	DWR_NA0010_27_t_2012_9					
Action/Comments						
Inspector Comments: The structure has 1 metal culvert at the base of each wing wall that appear to be in good shape with no visible signs of deterioration. 1 CMP along the headwall that connects between the culverts on each wing wall.

CMP that connect between culverts risers on left and right wing wall.
(2020)

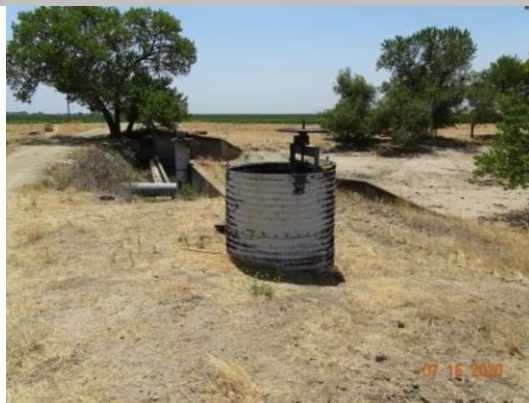
Photo 1 of 2 : ST_2020_NA0010_27_12_20200721_00036.jpg

LM Start	0.00	Rating **	A	Issue No.	12
LM End	0.00	Issue Type +	Ma	Location *	
Category	Structures & Concrete Lined Channels			GPS Latitude/Longitude	
				Start	End
Item	Sluice/Slide Gates			37.045045 °	37.045045 °
				-120.429855 °	-120.429855 °
DWR ID	DWR_NA0010_27_t_2012_12				
Action/Comments					
Inspector Comments: The structure includes 1 slide gate on each bank. Both are operational.

Slide gate on the right bank. (2020)

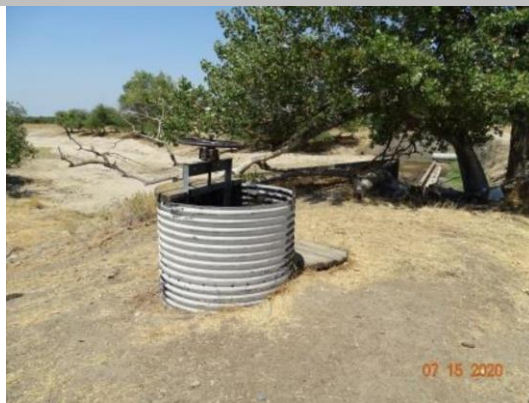
Photo 2 of 2 : ST_2020_NA0010_27_12_20200721_00037.jpg

Slide gate on the left bank. (2020)

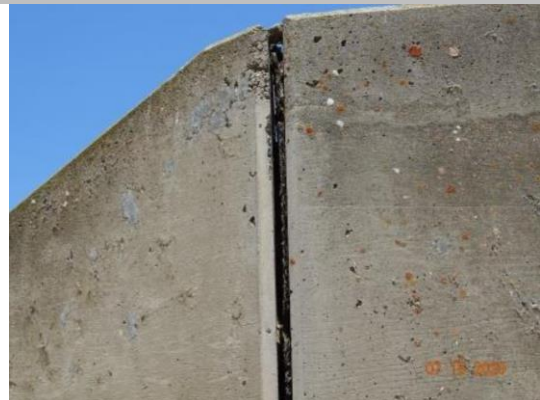
Photo 1 of 1 : ST_2020_NA0010_27_22_20200721_00038.jpg

LM Start	0.00	Rating **	M	Issue No.	22
LM End	0.00	Issue Type +	Ma	Location *	
Category	Structures & Concrete Lined Channels	GPS Latitude/Longitude			
		Start		End	
Item	Monolith Joints	37.045045 °		37.045045 °	
		-120.429855 °		-120.429855 °	
DWR ID	DWR_NA0010_27_t_2012_22				
Action/Comments					
Inspector Comments: The gasket on the right wingwalll is starting to deteriorate. Recommend repair.

View of gasket on right wingwall. (2020)

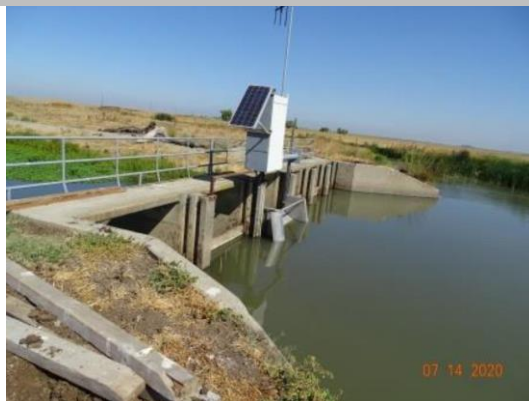
Photo 2 of 3 : ST_2020_NA0010_34_1_20200716_00020.jpg

View of upstream side of the structure from the left bank. (2020)

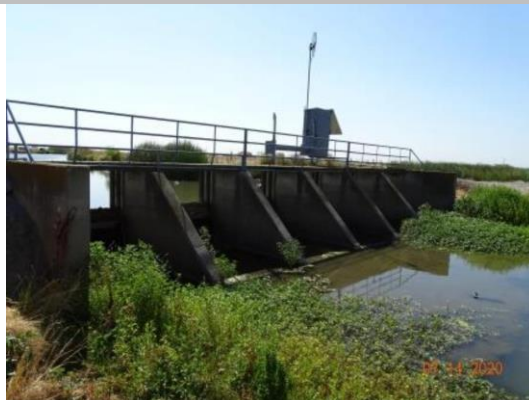
Photo 3 of 3 : ST_2020_NA0010_34_1_20200716_00022.jpg

View of downstream side of the structure from the right bank. (2020)

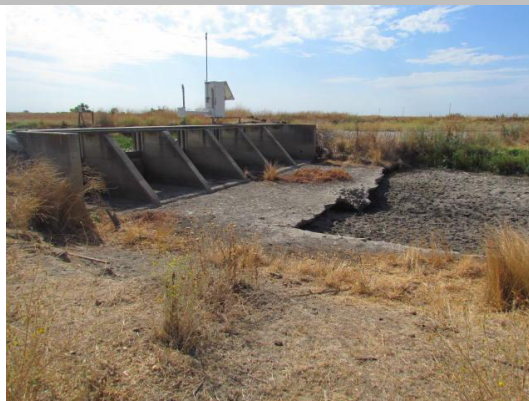
Photo 2 of 3 : ST_2020_NA0010_34_5_20200610_00007.jpg

LM Start	0.00	Rating **	M	Issue No.	5
LM End	0.00	Issue Type +	Ma	Location *	
Category	Structures & Concrete Lined Channels			GPS Latitude/Longitude	
				Start	End
Item	Revetments			37.254970 °	37.254970 °
				-120.718450 °	-120.718450 °
DWR ID	DWR_NA0010_34_t_2012_5				
Action/Comments					
Inspector Comments: Some minor revetment scouring on downstream side of structure was identified in previous inspections. Shadow of scour was visible during 2020 inspection.

Looking at revetment on downstream side of structure. (2015)

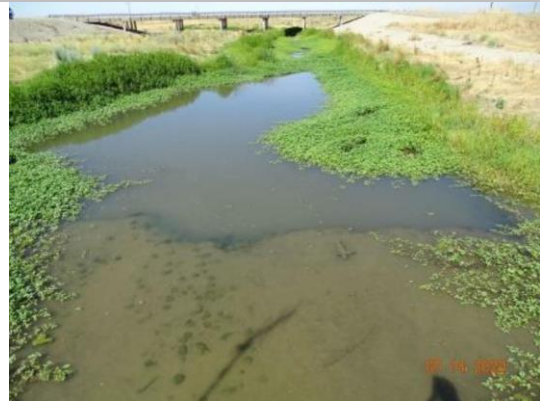
Photo 3 of 3 : ST_2020_NA0010_34_5_20200716_00023.jpg

LM Start	0.00	Rating **	M	Issue No.	5 (cont)	
LM End	0.00	Issue Type +	Ma	Location *		
Category	Structures & Concrete Lined Channels			GPS Latitude/Longitude		
				Start		End
Item	Revetments			37.254970 °		37.254970 °
				-120.718450 °		-120.718450 °
DWR ID	DWR_NA0010_34_t_2012_5					
Action/Comments						
Inspector Comments: Some minor revetment scouring on downstream side of structure was identified in previous inspections. Shadow of scour was visible during 2020 inspection.

Erosion of the downstream revetment. (2020)

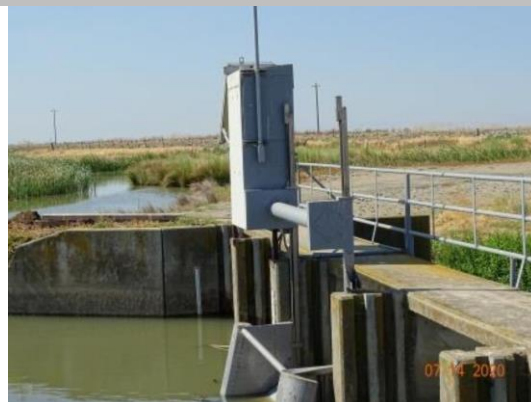
Photo 1 of 2 : ST_2020_NA0010_34_13_20200716_00027.jpg

LM Start	0.00	Rating **	A	Issue No.	13
LM End	0.00	Issue Type +	Ma	Location *	
Category	Structures & Concrete Lined Channels	GPS Latitude/Longitude			
		Start	End		
Item	Electric Gate Operators	37.254970 °		37.254970 °	
		-120.718450 °		-120.718450 °	
DWR ID	DWR_NA0010_34_t_2012_13				
Action/Comments					
Inspector Comments: Electric gate appears to be properly maintained and is in good working condition.

View of the gate operator from the right. (2020)

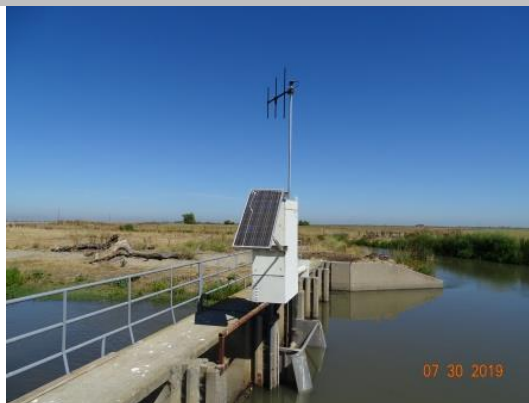
Photo 2 of 2 : ST_2020_NA0010_34_13_20200610_00009.jpg

LM Start	0.00	Rating **	A	Issue No.	13 (cont)	
LM End	0.00	Issue Type +	Ma	Location *		
Category	Structures & Concrete Lined Channels			GPS Latitude/Longitude		
				Start	End	
Item	Electric Gate Operators			37.254970 °	37.254970 °	
				-120.718450 °	-120.718450 °	
DWR ID	DWR_NA0010_34_t_2012_13					
Action/Comments						
Inspector Comments: Electric gate appears to be properly maintained and is in good working condition.

Looking at gate operator on upstream side of structure. (2019)

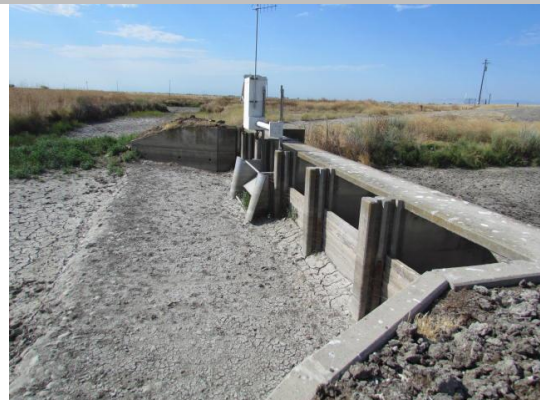
Photo 1 of 3 : ST_2020_NA0010_34_17_20200610_00014.jpg

LM Start	0.00	Rating **	A	Issue No.	17
LM End	0.00	Issue Type +	Ma	Location *	
Category	Structures & Concrete Lined Channels	GPS Latitude/Longitude			
		Start		End	
Item	Concrete Foundations	37.254970 °		37.254970 °	
		-120.718450 °		-120.718450 °	
DWR ID	DWR_NA0010_34_t_2012_17				
Action/Comments					
Inspector Comments: No visible erosion near foundation.

Looking at upstream side of structure.

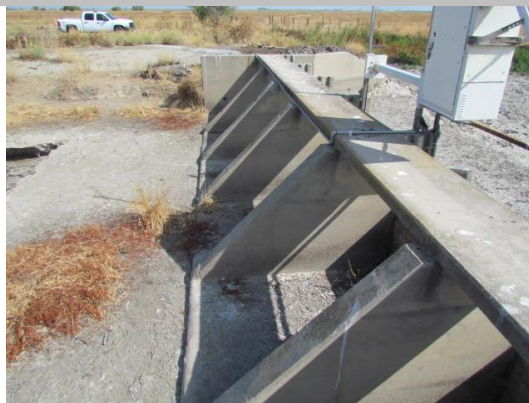
Photo 2 of 3 : ST_2020_NA0010_34_17_20200610_00015.jpg

LM Start	0.00	Rating **	A	Issue No.	17 (cont)	
LM End	0.00	Issue Type +	Ma	Location *		
Category	Structures & Concrete Lined Channels			GPS Latitude/Longitude		
				Start	End	
Item	Concrete Foundations			37.254970 °	37.254970 °	
				-120.718450 °	-120.718450 °	
DWR ID	DWR_NA0010_34_t_2012_17					
Action/Comments						
Inspector Comments: No visible erosion near foundation.

Looking at downstream side of structure.

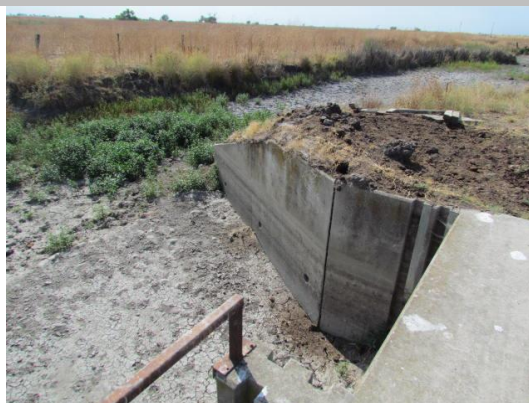
Photo 3 of 3 : ST_2020_NA0010_34_17_20200610_00016.jpg

Looking at left wing wall on upstream side of structure.

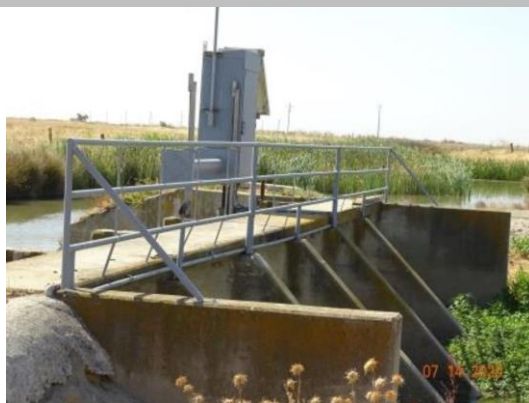
Photo 1 of 1 : ST_2020_NA0010_34_23_20200716_00029.jpg

LM Start	0.00	Rating **	A	Issue No.	23	
LM End	0.00	Issue Type +	Ma	Location *		
Category	Structures & Concrete Lined Channels			GPS Latitude/Longitude		
				Start		End
Item	Safety			37.254970 °		37.254970 °
				-120.718450 °		-120.718450 °
DWR ID	DWR_NA0010_34_t_2012_23					
Action/Comments						
Inspector Comments: No visible hazards near the structure.

Handrails on the downstream side of the structure. (2020)

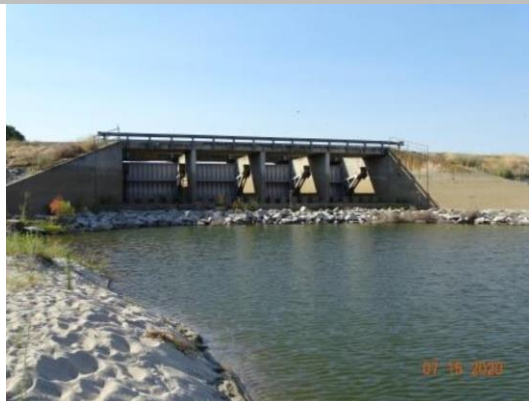
Photo 1 of 3 : ST_2020_NA0010_65_1_20200720_00011.jpg

LM Start	0.00	Rating **	N	Issue No.	1
LM End	0.00	Issue Type +	Ma	Location *	
Category	Structures & Concrete Lined Channels			GPS Latitude/Longitude	
				Start	End
Item	Photo Documentation			36.774021 °	36.774021 °
				-120.284476 °	-120.284476 °
DWR ID	DWR_NA0010_65_t_2017_1				
Action/Comments					
Inspector Comments: Structure appears to be properly maintained.

View of the downstream side of the structure. (2020)

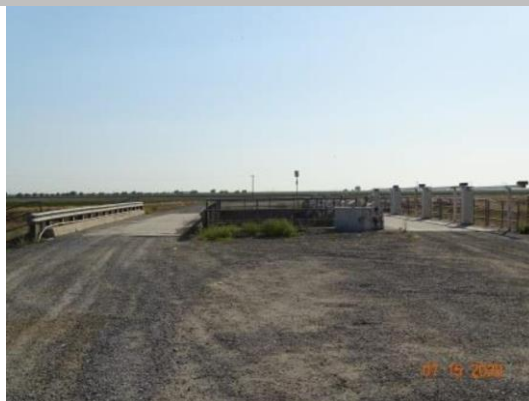
Photo 2 of 3 : ST_2020_NA0010_65_1_20200720_00010.jpg

View of the top of the structure from the left bank. (2020)

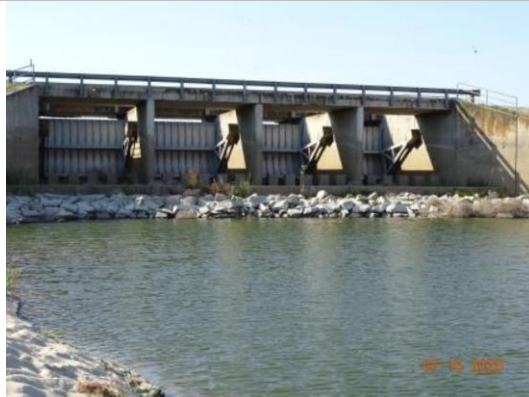
Photo 1 of 2 : ST_2020_NA0010_65_7_20200720_00012.jpg

LM Start	0.00	Rating **	A	Issue No.	7	
LM End	0.00	Issue Type +	Ma	Location *		
Category	Structures & Concrete Lined Channels			GPS Latitude/Longitude		
				Start		End
Item	Culverts: Inlets / Outlets			36.774021 °		36.774021 °
				-120.284476 °		-120.284476 °
DWR ID	DWR_NA0010_65_t_2017_7					
Action/Comments						
Inspector Comments: No obstructions identified in inlets and outlets.

View of the structure outlets. (2020)

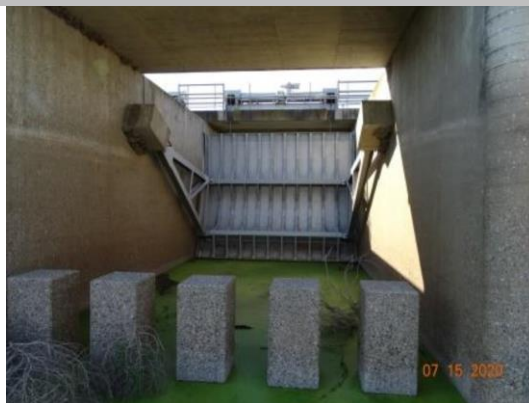
Photo 2 of 2 : ST_2020_NA0010_65_7_20200720_00013.jpg

LM Start	0.00	Rating **	A	Issue No.	7 (cont)	
LM End	0.00	Issue Type +	Ma	Location *		
Category	Structures & Concrete Lined Channels			GPS Latitude/Longitude		
				Start		End
Item	Culverts: Inlets / Outlets			36.774021 °	36.774021 °	
				-120.284476 °	-120.284476 °	
DWR ID	DWR_NA0010_65_t_2017_7					
Action/Comments						
Inspector Comments: No obstructions identified in inlets and outlets.

Typical view of the outlet. (2020)

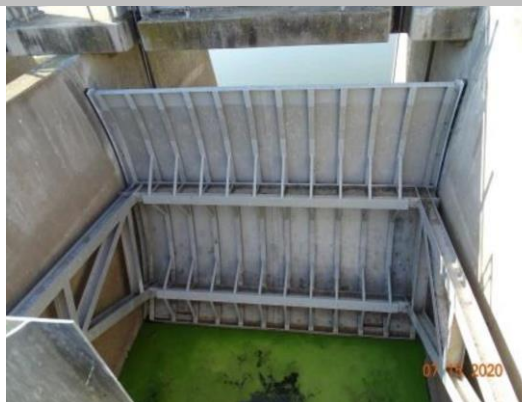
Photo 1 of 1 : ST_2020_NA0010_65_12_20200720_00014.jpg

LM Start	0.00	Rating **	A	Issue No.	12
LM End	0.00	Issue Type +	Ma	Location *	
Category	Structures & Concrete Lined Channels			GPS Latitude/Longitude	
				Start	End
Item	Sluice/Slide Gates			36.774021 °	36.774021 °
				-120.284476 °	-120.284476 °
DWR ID	DWR_NA0010_65_t_2017_12				
Action/Comments					
Inspector Comments: Gates are operable and appear to be well maintained.

Representative picture of the gates. (2020)

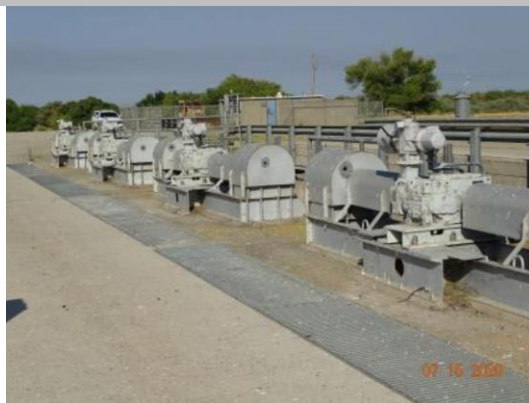
Photo 1 of 2 : ST_2020_NA0010_65_13_20200720_00015.jpg

LM Start	0.00	Rating **	A	Issue No.	13
LM End	0.00	Issue Type +	Ma	Location *	
Category	Structures & Concrete Lined Channels	GPS Latitude/Longitude			
		Start		End	
Item	Electric Gate Operators	36.774021 °		36.774021 °	
		-120.284476 °		-120.284476 °	
DWR ID	DWR_NA0010_65_t_2017_13				
Action/Comments					
Inspector Comments: Electric gate operators appear to be in good working condition.

View of electric gate operators. (2020)

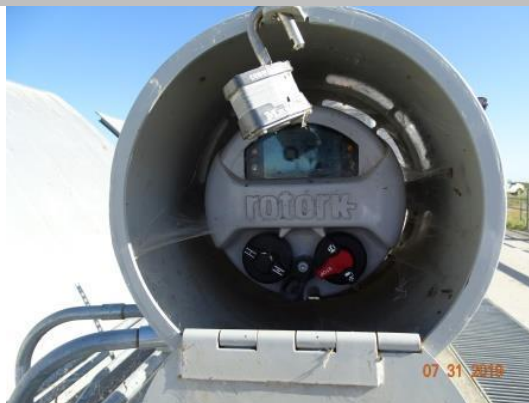
Photo 2 of 2 : ST_2020_NA0010_65_13_20200610_00007.jpg

Representative view of electric gate controls. (2019)

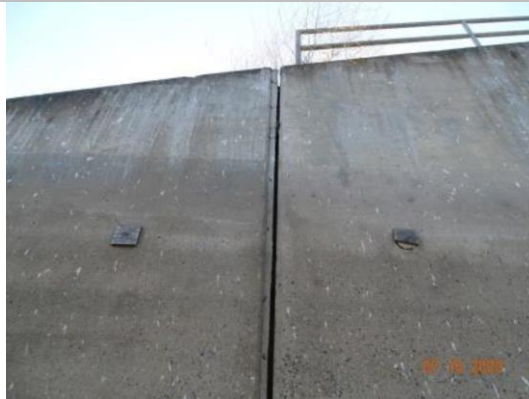
Photo 3 of 3 : ST_2020_NA0010_65_22_20200720_00017.jpg

LM Start	0.00	Rating **	A	Issue No.	22 (cont)	
LM End	0.00	Issue Type +	Ma	Location *		
Category	Structures & Concrete Lined Channels			GPS Latitude/Longitude		
				Start		End
Item	Monolith Joints			36.774021 °		36.774021 °
				-120.284476 °		-120.284476 °
DWR ID	DWR_NA0010_65_t_2017_22					
Action/Comments						
Inspector Comments: Joint material is deteriorating, identified along the top on the roadway side of the structure and right wing wall. Recommend monitoring and repairing if the deterioration worsens.

Minor deterioration of joint on right wing wall. (2020)

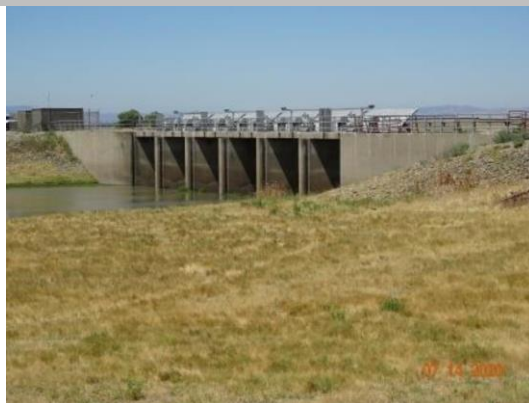
Photo 1 of 3 : ST_2020_NA0010_43_1_20200717_00016.jpg

View of the upstream side of the structure. (2020)

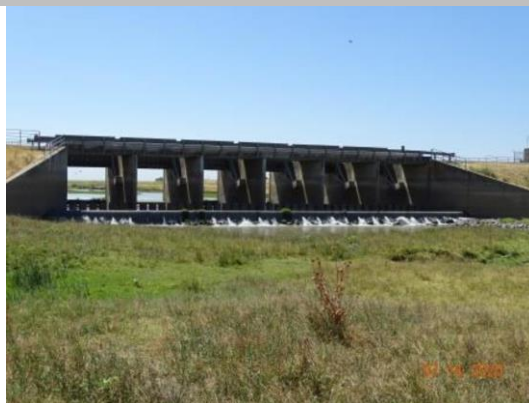
Photo 2 of 3 : ST_2020_NA0010_43_1_20200717_00015.jpg

View of the downstream side of the structure. (2020)

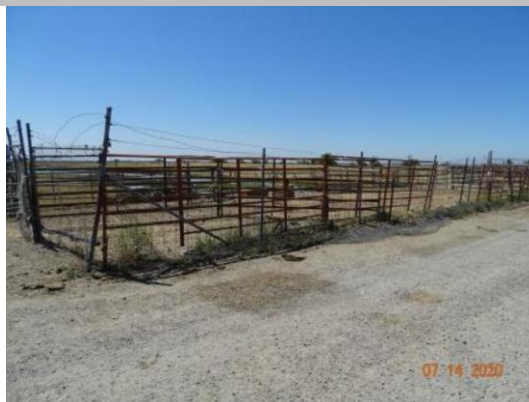
Photo 1 of 2 : ST_2020_NA0010_43_6_20200717_00017.jpg

LM Start	0.00	Rating **	M	Issue No.	6
LM End	0.00	Issue Type +	Ma	Location *	
Category	Structures & Concrete Lined Channels			GPS Latitude/Longitude	
				Start	End
Item	Encroachments			37.204867 °	37.204867 °
				-120.696985 °	-120.696985 °
DWR ID	DWR_NA0010_43_t_2012_6				
Action/Comments					
Inspector Comments: Makeshift animal pen was put up on the top right side of the structure.

View of the animal pen encroachment looking upstream. (2020)

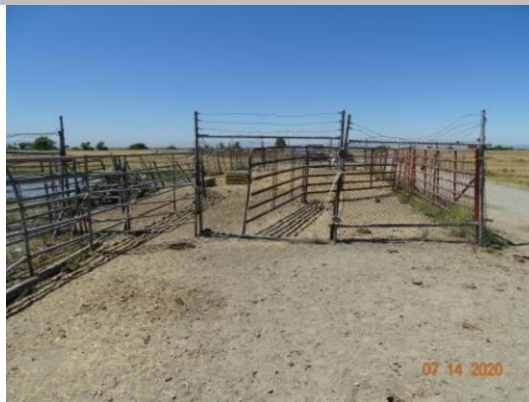
Photo 2 of 2 : ST_2020_NA0010_43_6_20200717_00018.jpg

View of animal pen from the right bank looking towards the structure. (2020)

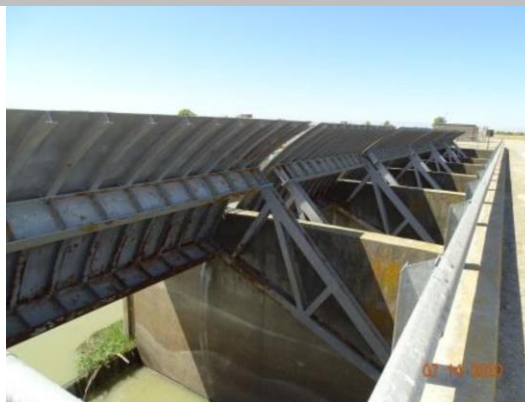
Photo 1 of 3 : ST_2020_NA0010_43_12_20200717_00019.jpg

LM Start	0.00	Rating **	A	Issue No.	12
LM End	0.00	Issue Type +	Ma	Location *	
Category	Structures & Concrete Lined Channels	GPS Latitude/Longitude			
		Start	End		
Item	Sluice/Slide Gates	37.204867 °		37.204867 °	
		-120.696985 °		-120.696985 °	
DWR ID	DWR_NA0010_43_t_2012_12				
Action/Comments					
Inspector Comments: Item appears to be adequately maintained and able to perform as intended. At least one grease fitting is not connected to hinge point on gate.

View of the control gates. (2020)

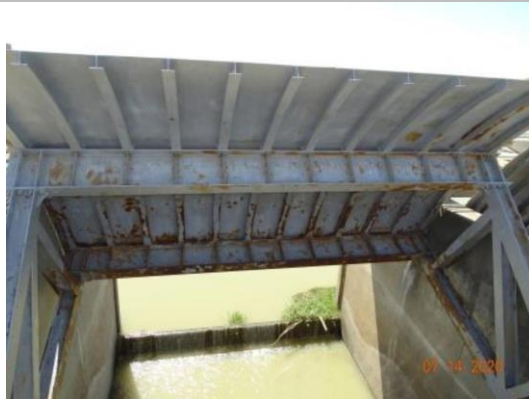
Photo 2 of 3 : ST_2020_NA0010_43_12_20200717_00020.jpg

LM Start	0.00	Rating **	A	Issue No.	12 (cont)
LM End	0.00	Issue Type +	Ma	Location *	
Category	Structures & Concrete Lined Channels	GPS Latitude/Longitude			
		Start		End	
Item	Sluice/Slide Gates	37.204867 °		37.204867 °	
		-120.696985 °		-120.696985 °	
DWR ID	DWR_NA0010_43_t_2012_12				
Action/Comments					
Inspector Comments: Item appears to be adequately maintained and able to perform as intended. At least one grease fitting is not connected to hinge point on gate.

Typical view of the radial gate. (2020)

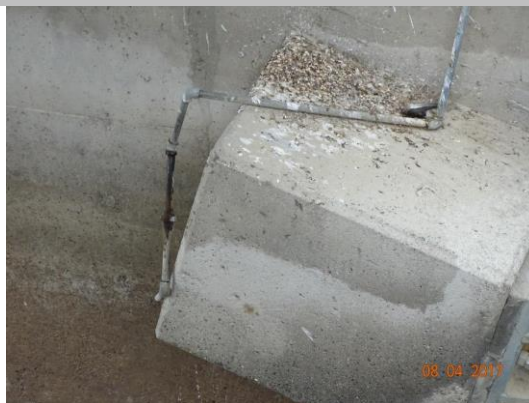
Photo 3 of 3 : ST_2020_NA0010_43_12_20200610_00006.jpg

View of grease point that is not connected. (2017)

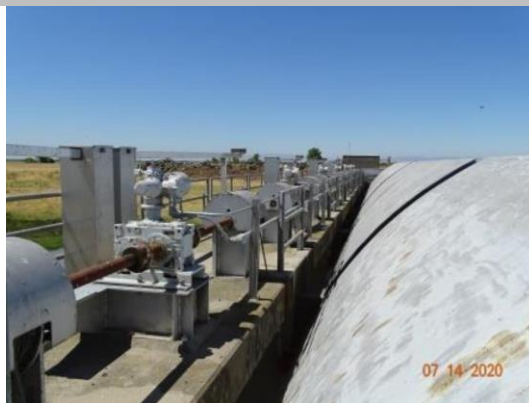
Photo 1 of 3 : ST_2020_NA0010_43_13_20200717_00021.jpg

LM Start	0.00	Rating **	A	Issue No.	13
LM End	0.00	Issue Type +	Ma	Location *	
Category	Structures & Concrete Lined Channels	GPS Latitude/Longitude			
		Start		End	
Item	Electric Gate Operators	37.204867 °		37.204867 °	
		-120.696985 °		-120.696985 °	
DWR ID	DWR_NA0010_43_t_2012_13				
Action/Comments					
Inspector Comments: Gate operators perform as intended and appear to be adequately maintained.

View of the electric gate motors. (2020)

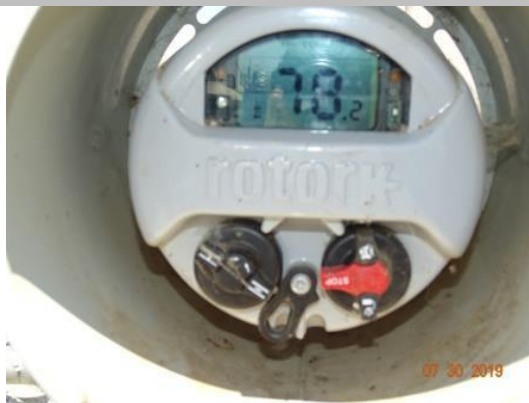
Photo 2 of 3 : ST_2020_NA0010_43_13_20200610_00008.jpg

LM Start	0.00	Rating **	A	Issue No.	13 (cont)
LM End	0.00	Issue Type +	Ma	Location *	
Category	Structures & Concrete Lined Channels			GPS Latitude/Longitude	
				Start	End
Item	Electric Gate Operators			37.204867 °	37.204867 °
				-120.696985 °	-120.696985 °
DWR ID	DWR_NA0010_43_t_2012_13				
Action/Comments					
Inspector Comments: Gate operators perform as intended and appear to be adequately maintained.

Typical view of electric gate controls. (2019)

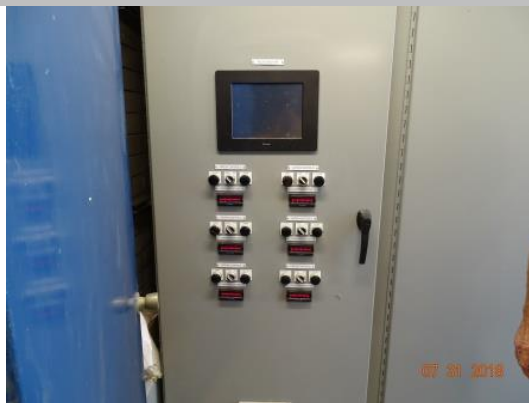
Photo 3 of 3 : ST_2020_NA0010_43_13_20200610_00009.jpg

View of control panel. (2018)

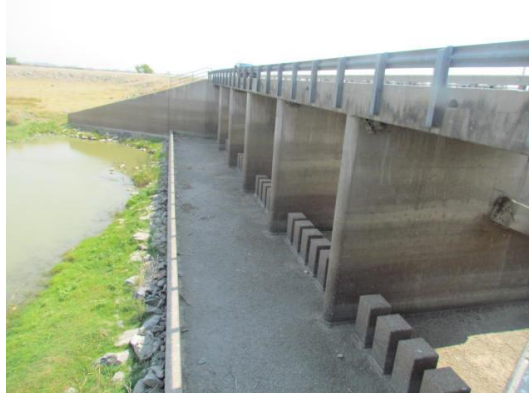
Photo 1 of 2 : ST_2020_NA0010_43_17_20200610_00010.jpg

LM Start	0.00	Rating **	A	Issue No.	17
LM End	0.00	Issue Type +	Ma	Location *	
Category	Structures & Concrete Lined Channels			GPS Latitude/Longitude	
				Start	End
Item	Concrete Foundations			37.204867 °	37.204867 °
				-120.696985 °	-120.696985 °
DWR ID	DWR_NA0010_43_t_2012_17				
Action/Comments					
Inspector Comments: No visible erosion near foundation, unable to view full area due to water levels.

Looking at downstream side of structure. (2017)

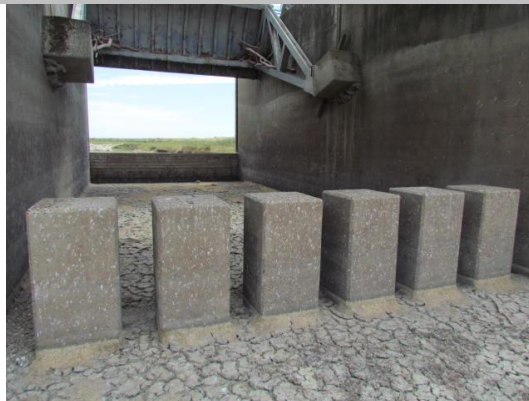
Photo 2 of 2 : ST_2020_NA0010_43_17_20200610_00011.jpg

LM Start	0.00	Rating **	A	Issue No.	17 (cont)	
LM End	0.00	Issue Type +	Ma	Location *		
Category	Structures & Concrete Lined Channels			GPS Latitude/Longitude		
				Start		End
Item	Concrete Foundations			37.204867 °		37.204867 °
				-120.696985 °		-120.696985 °
DWR ID	DWR_NA0010_43_t_2012_17					
Action/Comments						
Inspector Comments: No visible erosion near foundation, unable to view full area due to water levels.

Looking at typical of control structure bay. (2017)

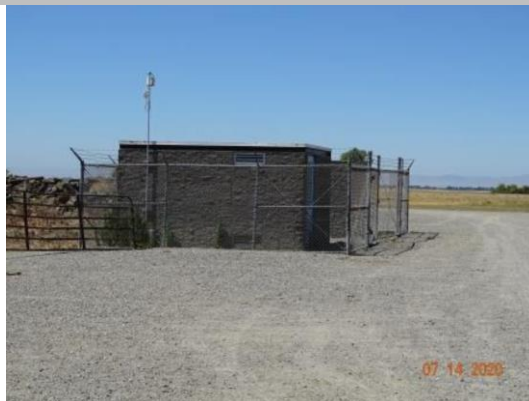
Photo 1 of 1 : ST_2020_NA0010_43_18_20200717_00022.jpg

LM Start	0.00	Rating **	A	Issue No.	18
LM End	0.00	Issue Type +	Ma	Location *	
Category	Structures & Concrete Lined Channels	GPS Latitude/Longitude			
		Start		End	
Item	Security Fencing	37.204867 °		37.204867 °	
		-120.696985 °		-120.696985 °	
DWR ID	DWR_NA0010_43_t_2012_18				
Action/Comments					
Inspector Comments: Security fencing around electrical house is in good condition.

View of fencing around the electrical housing. (2020)

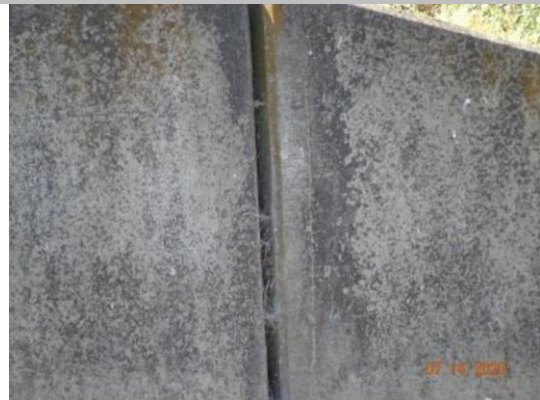
Photo 1 of 2 : ST_2020_NA0010_43_22_20200717_00023.jpg

LM Start	0.00	Rating **	A	Issue No.	22
LM End	0.00	Issue Type +	Ma	Location *	
Category	Structures & Concrete Lined Channels	GPS Latitude/Longitude			
		Start		End	
Item	Monolith Joints	37.204867 °		37.204867 °	
		-120.696985 °		-120.696985 °	
DWR ID	DWR_NA0010_43_t_2012_22				
Action/Comments					
Inspector Comments: Minor joint deterioration at wingwalls.

View of monolith joint at left wingwall. (2020)

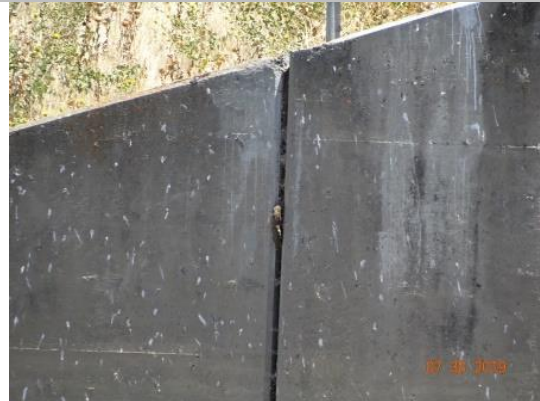
Photo 2 of 2 : ST_2020_NA0010_43_22_20200610_00013.jpg

LM Start	0.00	Rating **	A	Issue No.	22 (cont)
LM End	0.00	Issue Type +	Ma	Location *	
Category	Structures & Concrete Lined Channels	GPS Latitude/Longitude			
		Start		End	
Item	Monolith Joints	37.204867 °		37.204867 °	
		-120.696985 °		-120.696985 °	
DWR ID	DWR_NA0010_43_t_2012_22				
Action/Comments					
Inspector Comments: Minor joint deterioration at wingwalls.

View of monolith joint at right wingwall. (2019)

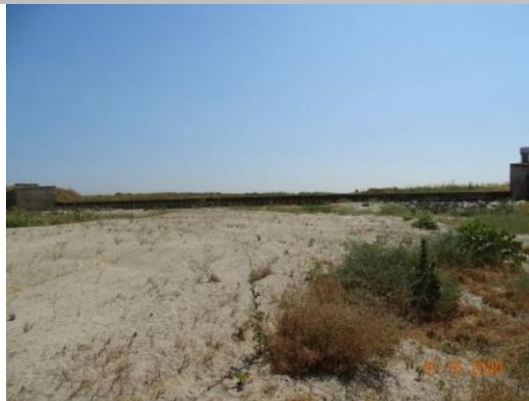
Photo 1 of 4 : ST_2020_NA0010_29_1_20200721_00017.jpg

Overview of the structure looking upstream. (2020)

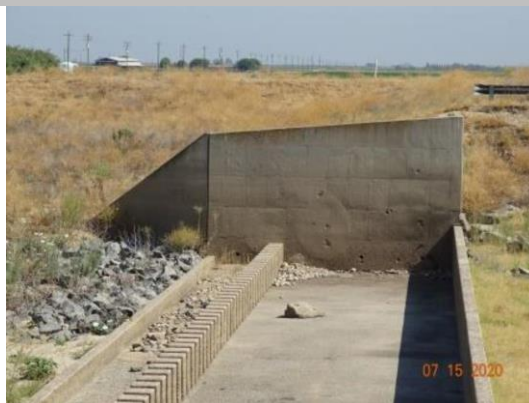
Photo 2 of 4 : ST_2020_NA0010_29_1_20200721_00016.jpg

View of the right wing wall. (2020)
